## HV bushing failure in service, diagnostics and modeling of oil-type bushings

Jacek Wańkowicz\* Jerzy Bielecki Marek Szrot Jan Subocz Ryszard Malewski  
Instytut Energetyki Energo-Complex ZUT Malewski Electric  
Poland  
[jacek.wankowicz@ien.com.pl](mailto:jacek.wankowicz@ien.com.pl)

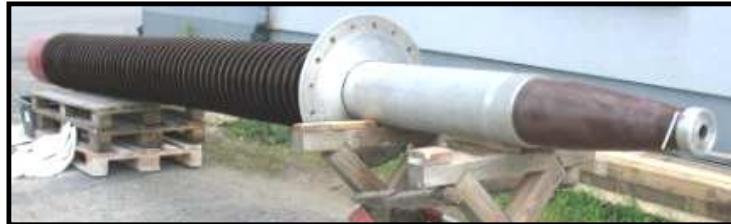
Fig.2. 400 kV transformer bushing type OIP that failed after some 30 years of service.

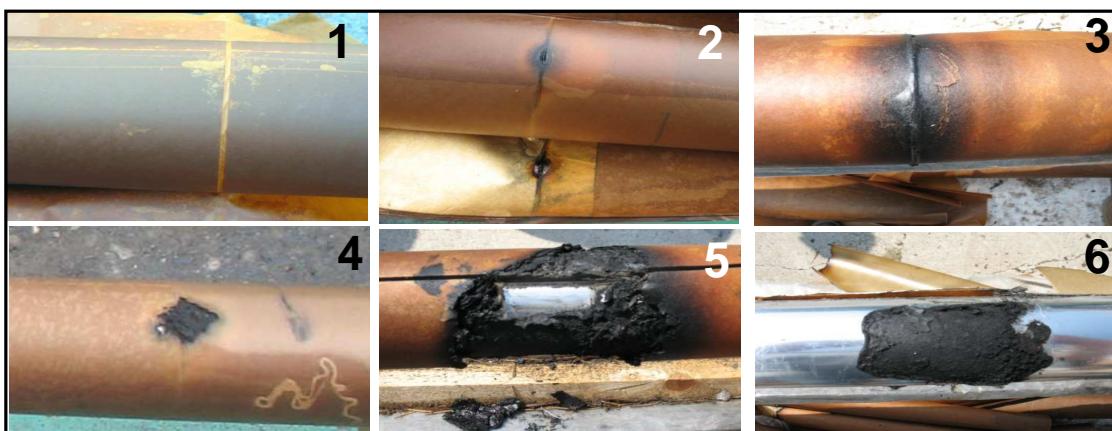
Fig. 3. Defective 400 kV OIP bushing core. Sequentially unwound layers of paper reveal carbonized pocket at approximately 60% of the bushing core length (counting from the bottom).

The outer layers were punctured at the gap between two adjacent paper sheets, visible in Fig. 3, first picture. This area was subjected to a higher stress, since the gap sandwiched between adjacent paper layers was filled with oil of nearly two fold lower dielectric strength than oil-saturated paper.

The high stress and high temperature in the wet-paper pocket accelerate degradation of cellulose, and water is one of decomposition products. A higher dielectric loss of the wet cellulose contributes to the local overheating and paper becomes carbonized after years of service [3]. Subsequently, the carbon short-circuits the inner paper layer, and the stress is shifted to the adjacent layers of the wet-paper pocket. Finally, the high potential is transferred to the healthy outer paper-layers that are punctured and break down under the excessive stress.

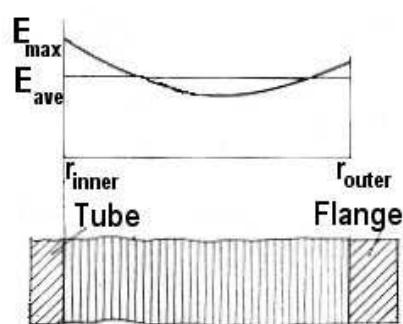
Fig. 1. Radial distribution of stress in the bushing core with the linear stress distribution along the porcelain-housing surface. Usually  $E_{\max} \leq 1,3 E_{\text{ave}}$ .

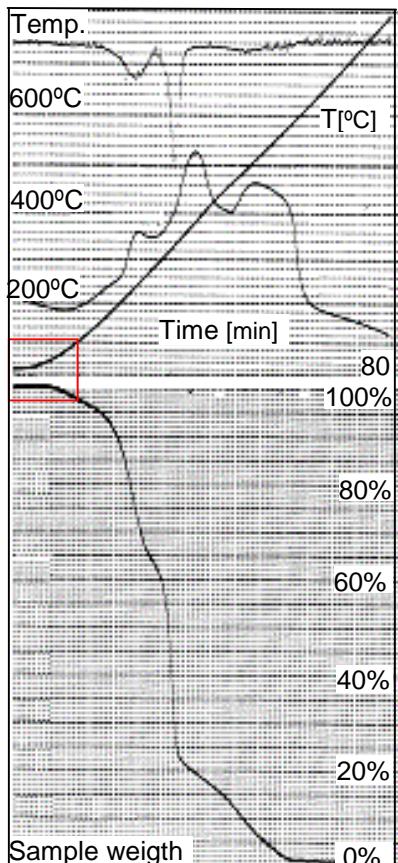
Fig. 4. Thermo-gravimetric record of paper sample taken from the bushing core close to the inner tube.

Although not very accurate, but water content in paper can be assessed by measuring the reduction of sample weight at 100°C (lower graph). The reading indicates a few percent (close to 5%) of water content in paper. This is a rather high value for bushing core, but not impossible considering the production of water due to the thermal decomposition of cellulose.

In consequence data read within 100°C range (marked by the rectangle) are not precise enough for quantitative determination, but provide indication of a rather high moisture content in paper sample taken in vicinity of the bushing inner-tube.

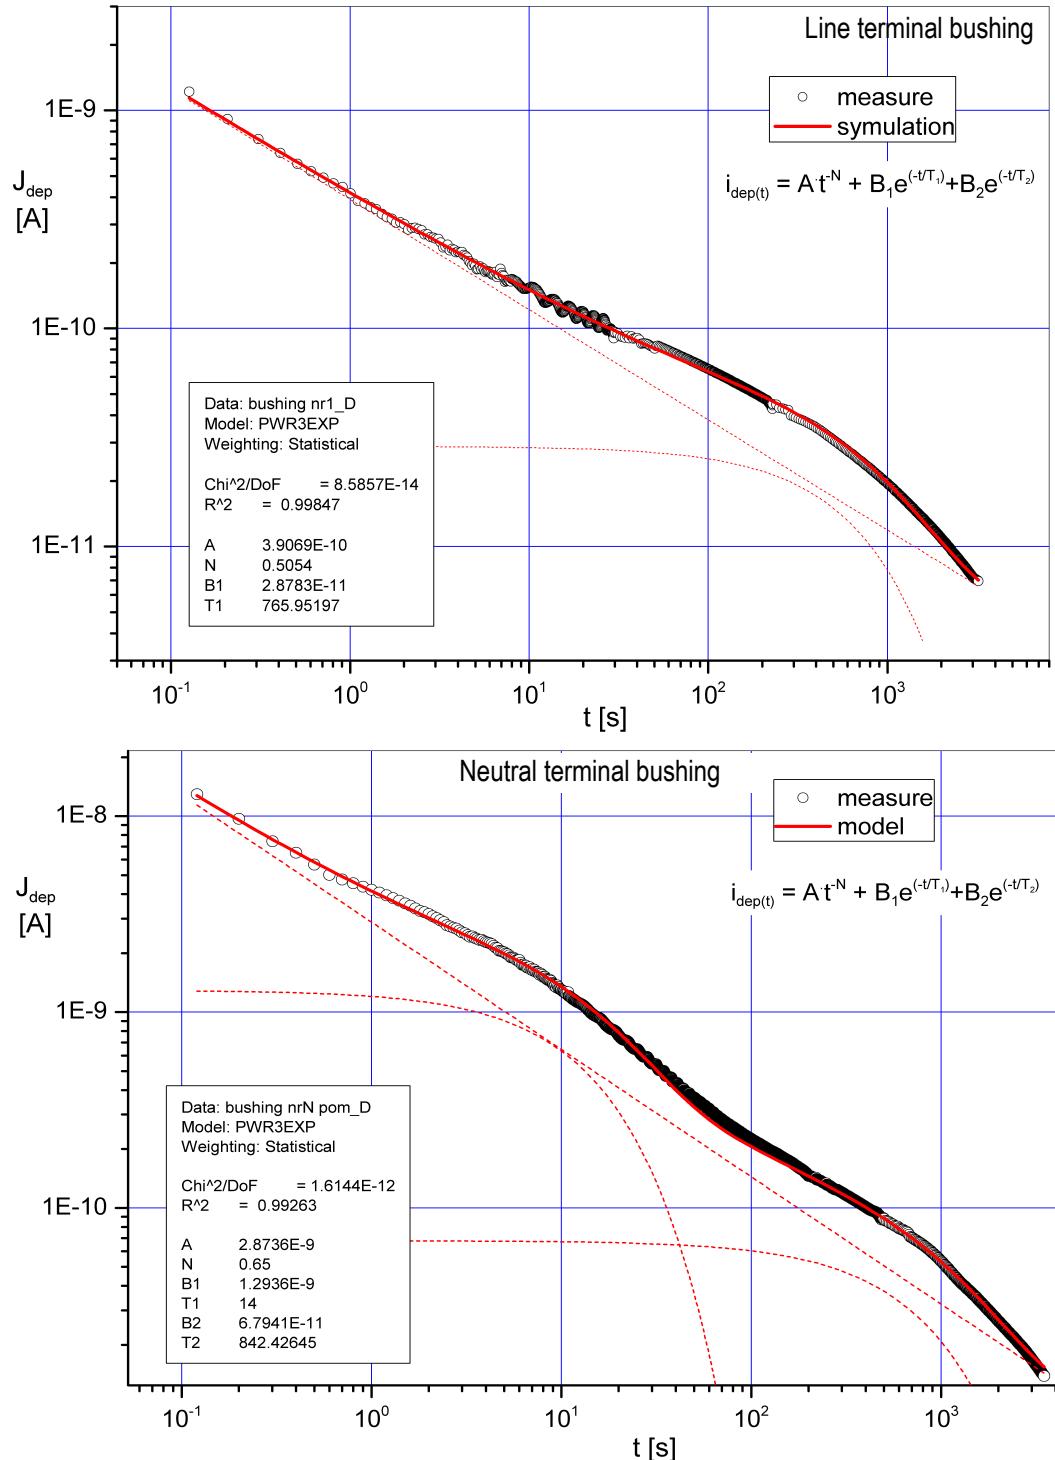
Fig. 5. Depolarization current recorded on the line-terminal (upper graph), and neutral-terminal (lower graph) bushings during one hour.

The parameters A, N, B1, T1, B2, T2 derived from of the depolarization current record were compared to the respective parameters of reference cellulose-samples conditioned and analyzed in the laboratory. Moisture content in bushing insulation was assessed at 1.1% to 1.5%.

The neutral-terminal bushing revealed a short time constant  $T_1=14$ s of the depolarization current. This must have been caused by relaxation of the space charge in an empty space within the insulation, which was left after a significant oil leak from the bushing.

The long time constant  $T_1=766$  s of the line terminal bushing and  $T_2=842$  s of the neutral-terminal bushing are characteristic to the low moisture content in cellulose.

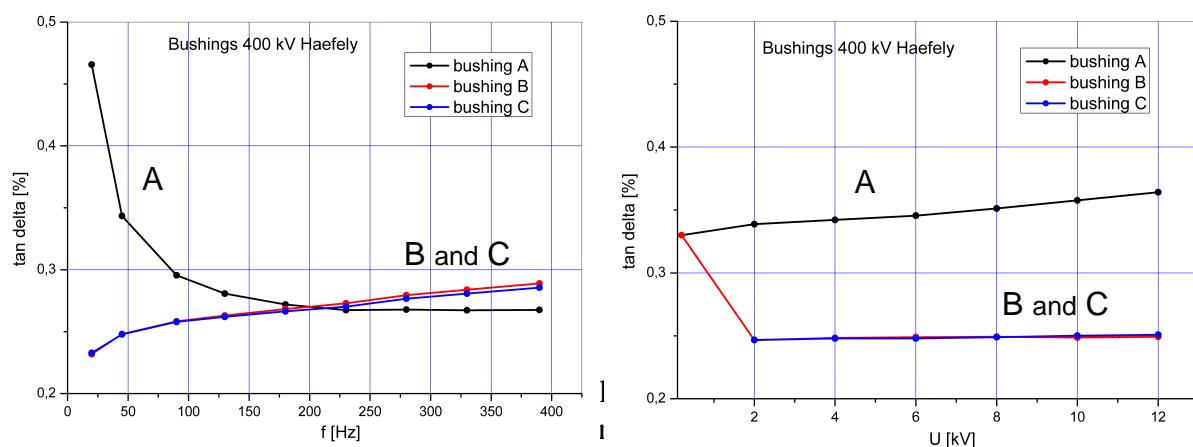
Fig. 7. Dielectric loss factor  $\tan \delta$  of three-phase 400 kV bushings measured as a function of frequency and test voltage.

A higher  $\tan\delta$  measured in the low-frequency range, and also at the increased test voltage suggested ingress of moisture to the phase A bushing. To confirm this finding the polarization  $i_{pol}$  and depolarization  $i_{dep}$  current was recorded, as well as the direct-current  $i_R$  flowing through the conductance of bushing core was derived.

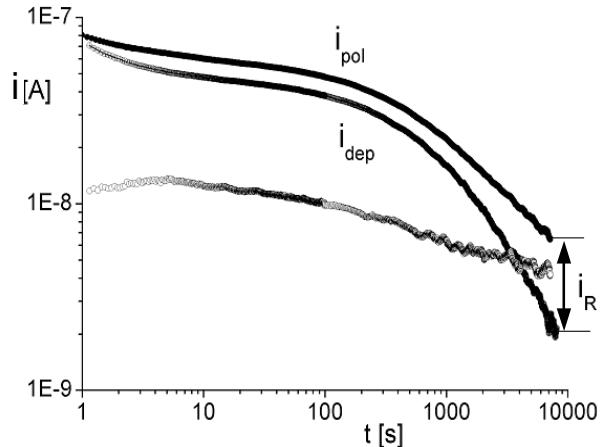
for bushing A:  $U_{pol} = 2000$  V,  $I_R \approx 7.6$  nA,  $\sigma \approx 0.09$  pS/m.

Fig. 6. Polarization  $i_{pol}$  and depolarization  $i_{dep}$  current recorded on three 400 kV bushings.

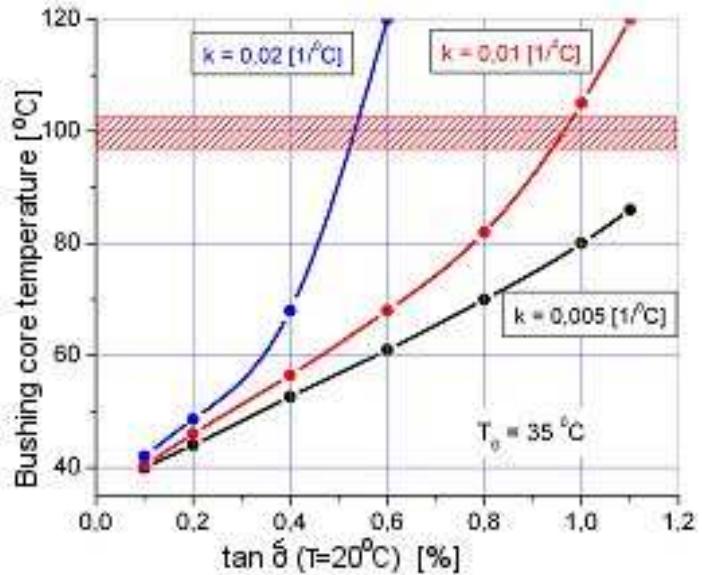
Fig. 9. The highest temperature inside the bushing core derived from the thermal model for the dielectric loss factor  $\tan\delta$  ranging from 0.01% to 1.2%, at the porcelain housing temperature  $T_0=35^\circ\text{C}$ , for the parameter  $k=0.005$ ; 0.01 and 0.02 that increases with the cellulose water-content and ageing ,

Although not yet confirmed by temperature measurements inside the bushing core, the thermal model indicates a real possibility of thermal breakdown of time-aged bushings with high moisture-content. The model predicted spot of the highest temperature coincides with the breakdown location of several bushings, observed at the post-mortem examination of failed units.
