## HV bushing failure in service, diagnostics and modeling of oil-type bushings

Jacek Wańkowicz\* Jerzy Bielecki Marek Szrot Jan Subocz Ryszard Malewski  
Instytut Energetyki Energo-Complex ZUT Malewski Electric  
Poland  
[jacek.wankowicz@ien.com.pl](mailto:jacek.wankowicz@ien.com.pl)

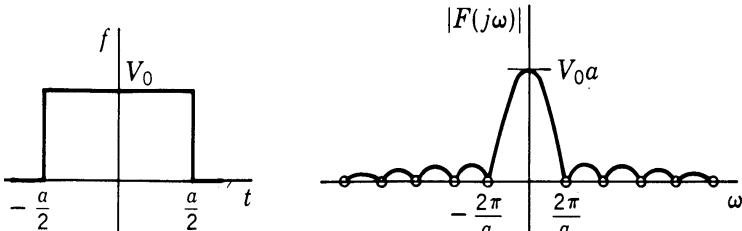
Fig. 10. Rectangular impulse of the width  $\tau=20\text{ ns}$  has spectral components that stretch to  $\sim 50\text{ MHz}$ .

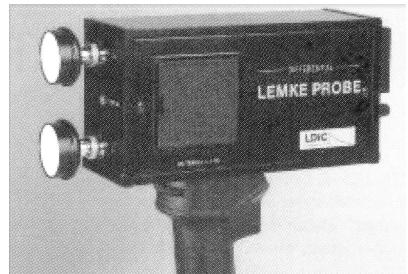
Fig. 11. "Lemke probe" detector of electromagnetic field radiated by partial-discharges in HV equipment.

This probe operates in frequency range of ~2 MHz, and can detect e.g. discharges in medium voltage cable joints. However, the probe frequency-range shall be at least ten times higher to detect partial discharges in HV bushing.
